Lead and Asbestos Survey and Sampling Reports and Letter (Scott Lawson Group, 1999)

Asbestos and Lead Survey at former Beck Woolen Mill

SLGL File Number 990666

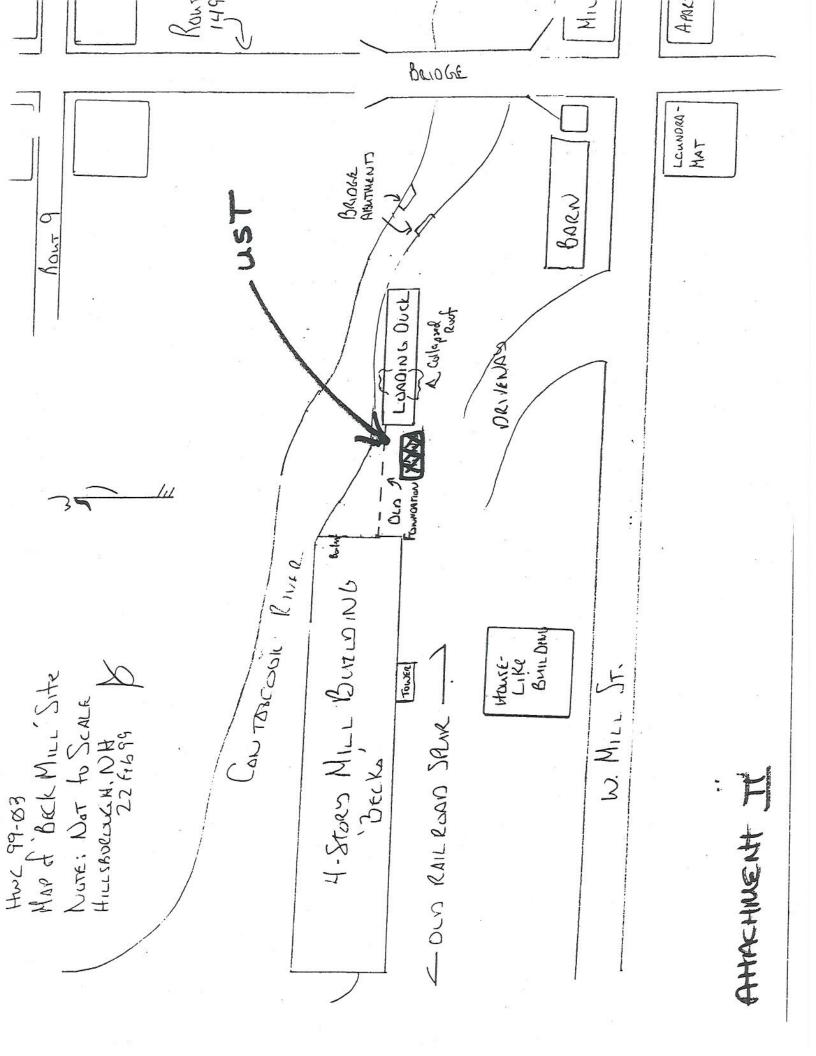
1. Telephone Message		Initial	
Name		Date:	
Street		Telephone:	
City		Fax #	
Facility Registration Number:	Unregistered		
Name Former Woods Woolen Mi	11 (Beck Mill Trust)	Ciry Willah	
Street _25 West Mill Street			oro
Owner Name			3 8
Name Leon Griffin, III	City_Hillsboro	Telephone: (603)	464-4937
Tank Removal Information		uspected: R=Removal,	
X R AX L	R F L R		
Tank # <u>N/A</u> Tank #	[M] Deci (00.0)		
Size 12,000 Size	Size	Size	
Product Product	11	Product	· · · · · · · · · · · · · · · · · · ·
Will tank be replaced Will tank	be replaced Will tank be replace		
underground? Yes No underground	? Yes No underground? Yes		No underground? Yes No
Consultant / Contractor: DES /	Franklin Environmental		
Local Fire Dept. Notified Hills	hote Fin D	- 111C.	•
Local Fire Dept. Notified Hills	ANO FITE DEDLY		
Inspector R. Wickson		Date December	22 & 26, 2001
Field Screening Methods (tank and	l piping):		
Photo Ionization I	etector - Headspace Sa	mnling Technique

ample Information		mbring recuirque	
tank # N/A tank #	tank #	tank #	
Soil 3 Water N/A Soil Water	Soil Water		tank #
Taken By: R. Wickson	10011 Water	Soil Water	Soil Water
ank Condition:			
tank # N/A tank #	· · ·	<del>-,</del>	6. 40
Pitting/Hole	tank#	tank #	tank #
ndicate tank and sample locations	by sketching on back of this	report. See Attac	hmont II
iclude photographs of the excavat	ion and tank(s) condition if	avaliable. See Attac	hment III
stimated cubic yards of stock pi	iled contaminated soil:		N/A cubic yards
Verification			
ave inspected the site of the removed tank chniques to determine regulated substance	(s), including the entire excavation	n area. I am knowledgab	le in field observation
hniques to determine regulated substance translation at the site. I have also inspected	contamination in soils and groun	water. There is no evide	nce of soil or groundwater
		no evidence of leakage.	- 50 - → 10 - 10 - 10 - 10 - 10 - 10 - 10 -
